LAKE SURVEY MAP

BEAVER DAM LAKE ASHLAND COUNTY
SEC. 1, 2, 31, 36 T. 44, 45 N. R. 3, 4 W.
SHEET 2 of 2

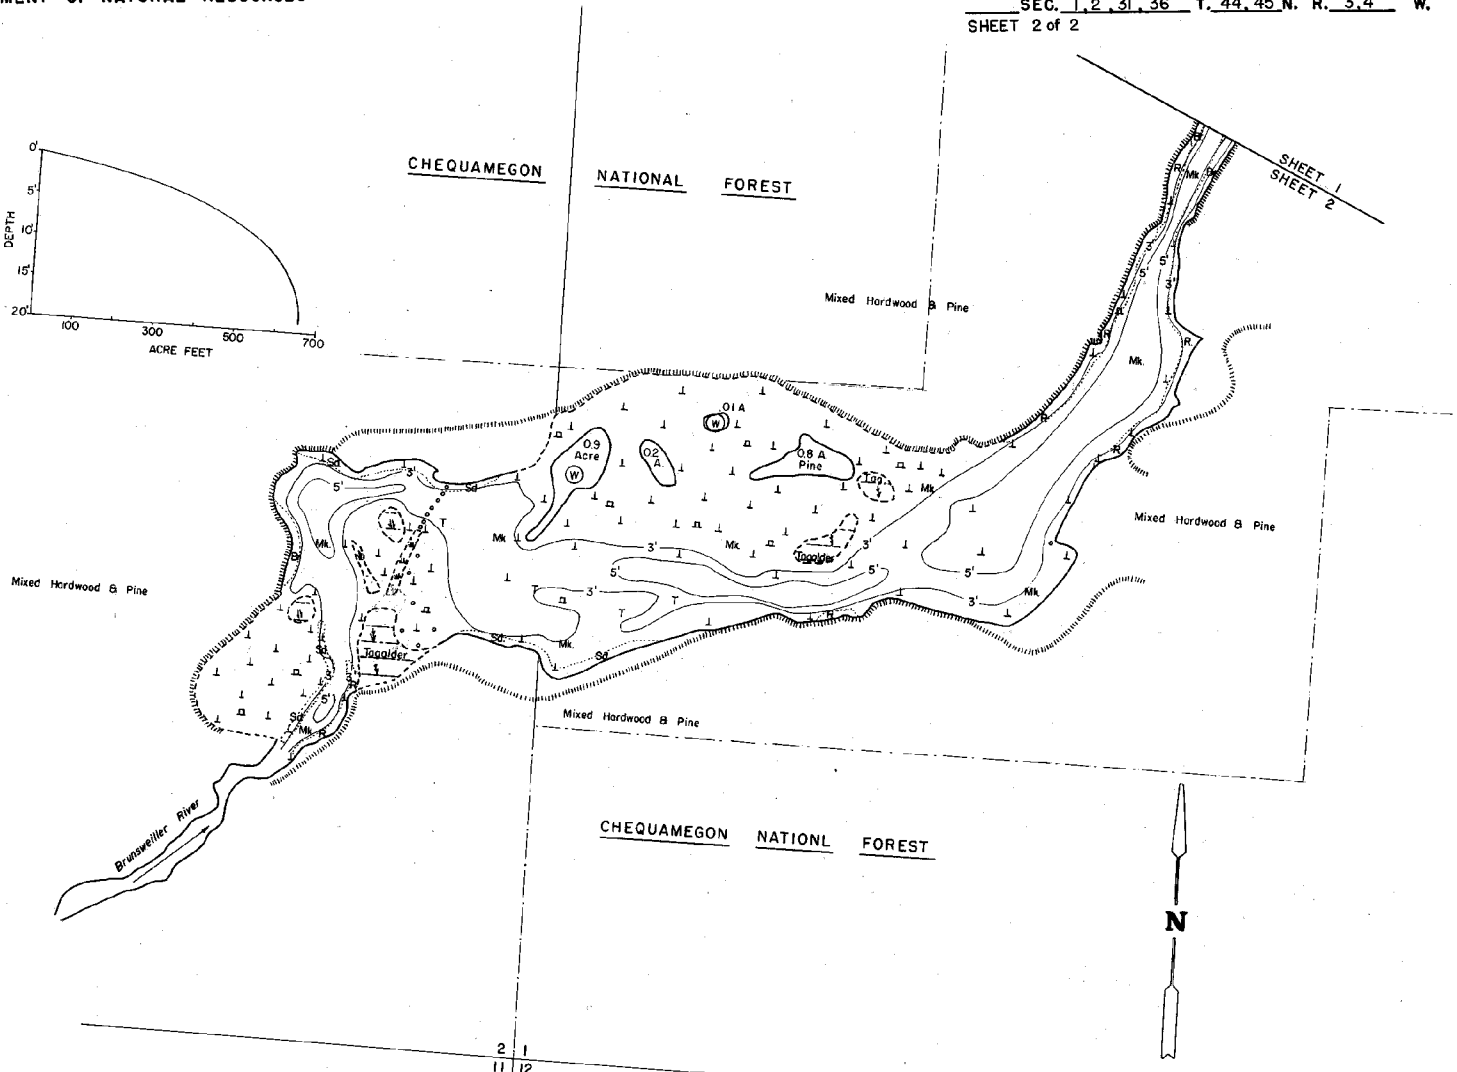
EQUIPMENT	RECORDING	SONAR	MAPPED	OCT.	1969
			MONTH	LAKE	YEAR
				BOTTOM	SYMBOLS
(B) Brush		Steep slope	P. Peat	B Boulders	
(PW) Partially wooded	-----	Indefinite shoreline	Mk. Muck	% Slumps & Snags	
(W) Wooded	-----	Marsh	C. Clay	Rock danger to navigation	
(C) Cleared	-----	Spring	M. Marl	T Submergent vegetation	
(P) Pastured	-----	Intermittent stream	Sd. Sand	1 Emergent vegetation	
(A) Agricultural	-----	Permanent inlet	Sl. Silt	Fl. Floating vegetation	
B.M. Bench Mark	-----	Permanent outlet	Gr. Gravel	Brush shelters	
■ Dwelling	-----	Dam	R. Rubble		
□ Resort	-----	D.N.R. State owned land	Br. Bedrock		
□ Camp	-----

WATER AREA 1180 ACRES
 UNDER 3 FT. 39 %
 OVER 20 FT. 0 %
 MAX. DEPTH 19 FEET.
 TOTAL ALK. 20 P.P.M.
 VOLUME 659.8 ACRE FT.
 SHORELINE 539 MILES
 SHORELINE 6.03 MILES WITH IS.
