STATE OF WISCONSIN
DEPARTMENT OF NATURAL RESOURCES

LAKE SURVEY MAP

CRANBERRY LAKE
VILAS-ONEIDA COUNTY
SEC. 30, 31, 32, 6 T. 39-40 N. R. 10-11 E.

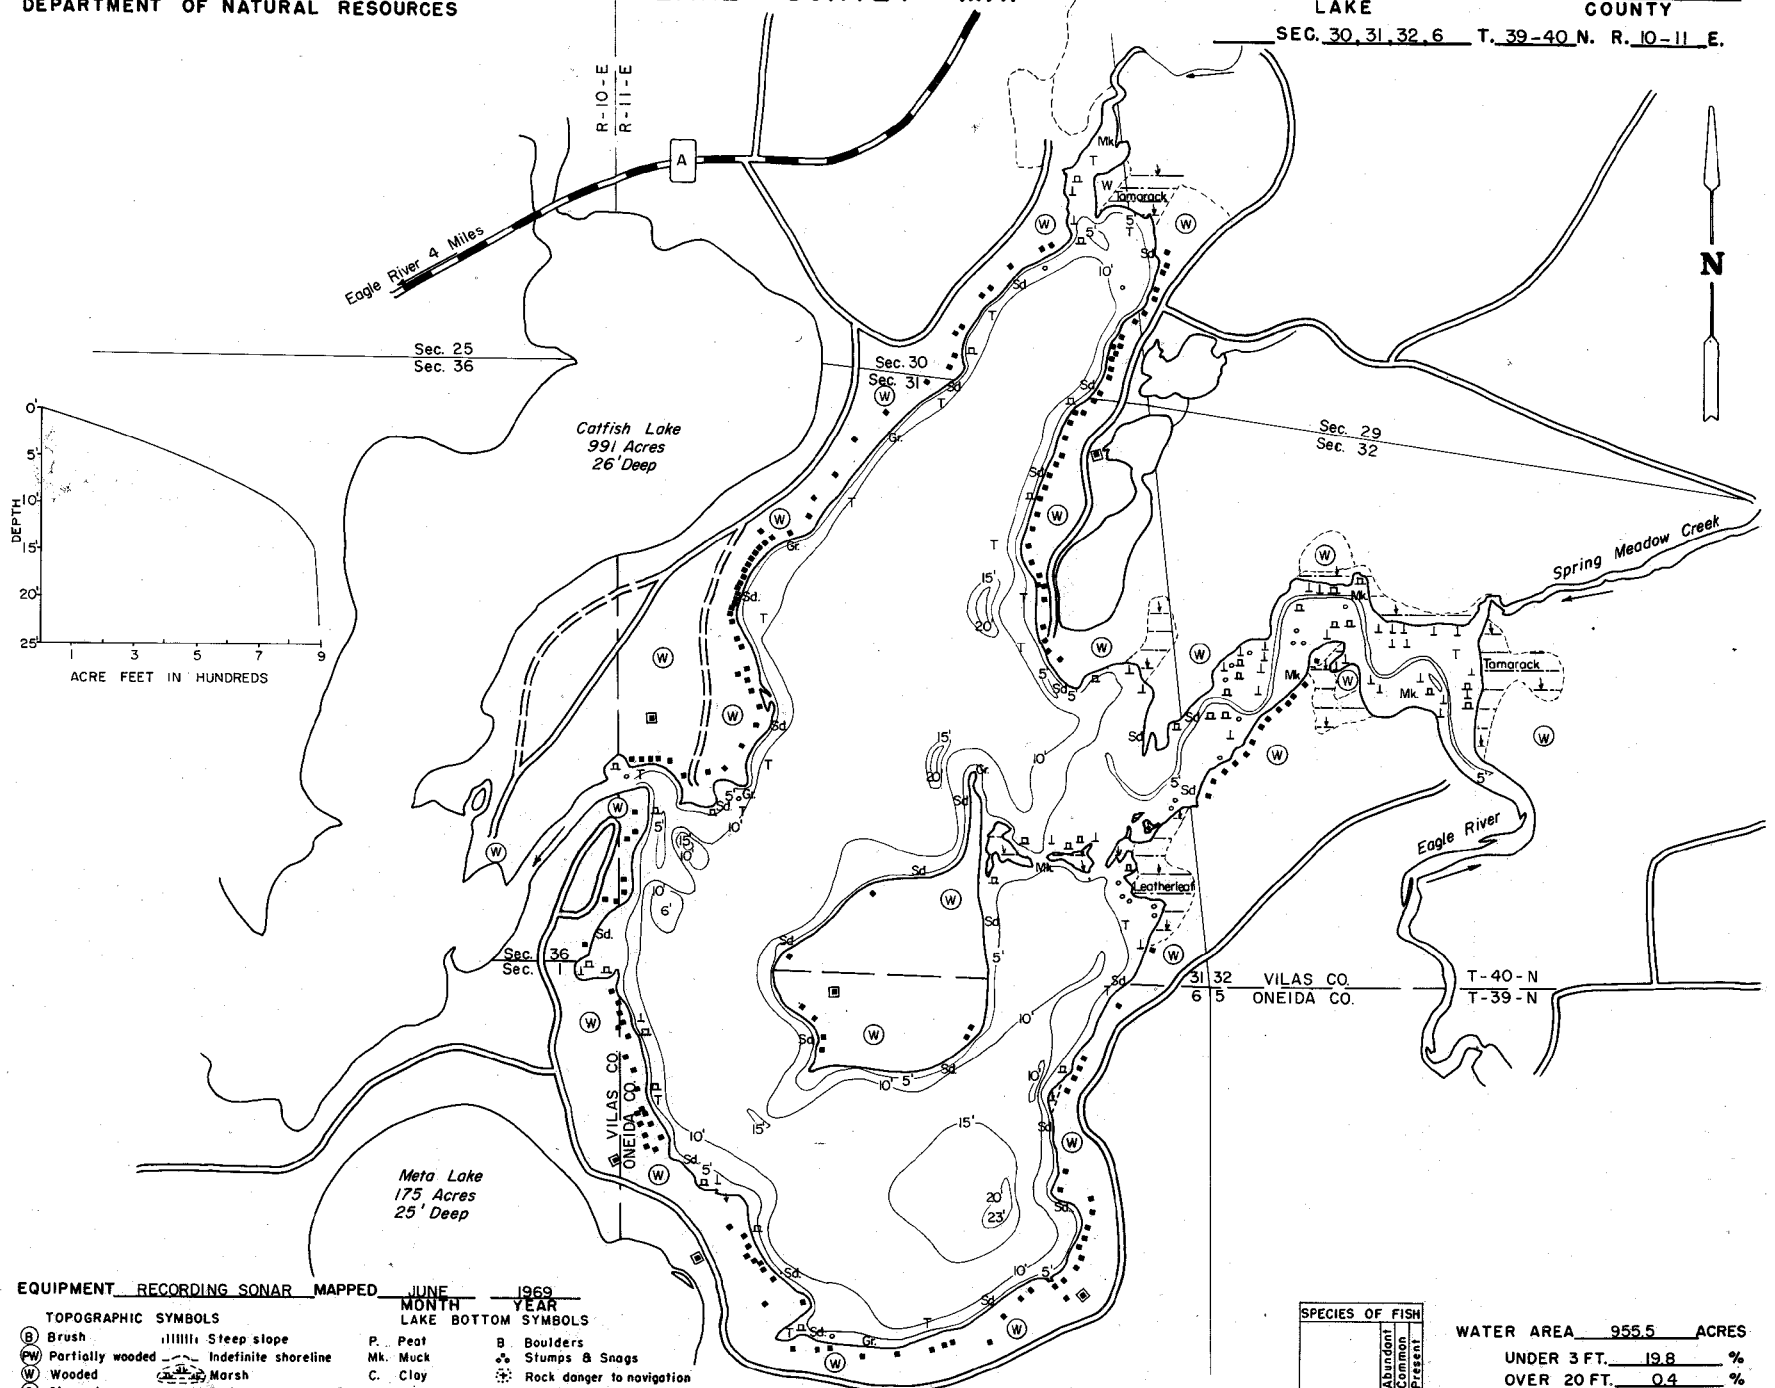
EQUIPMENT RECORDING SONAR MAPPED JUNE 1969
MONTH YEAR
LAKE BOTTOM SYMBOLS

WATER AREA 955.5 ACRES
 UNDER 3 FT. 19.8 %
 OVER 20 FT. 0.4 %
 MAX. DEPTH 23 FEET.
 TOTAL ALK. 31 P.P.M.
 VOLUME 8949.9 ACRE FT.
