STATE OF WISCONSIN  
DEPARTMENT OF NATURAL RESOURCES

LAKE SURVEY MAP

HEMLOCK ONEIDA  
LAKE COUNTY  
SEC. 8, 17, 18 T. 39 N. R. 7 E.

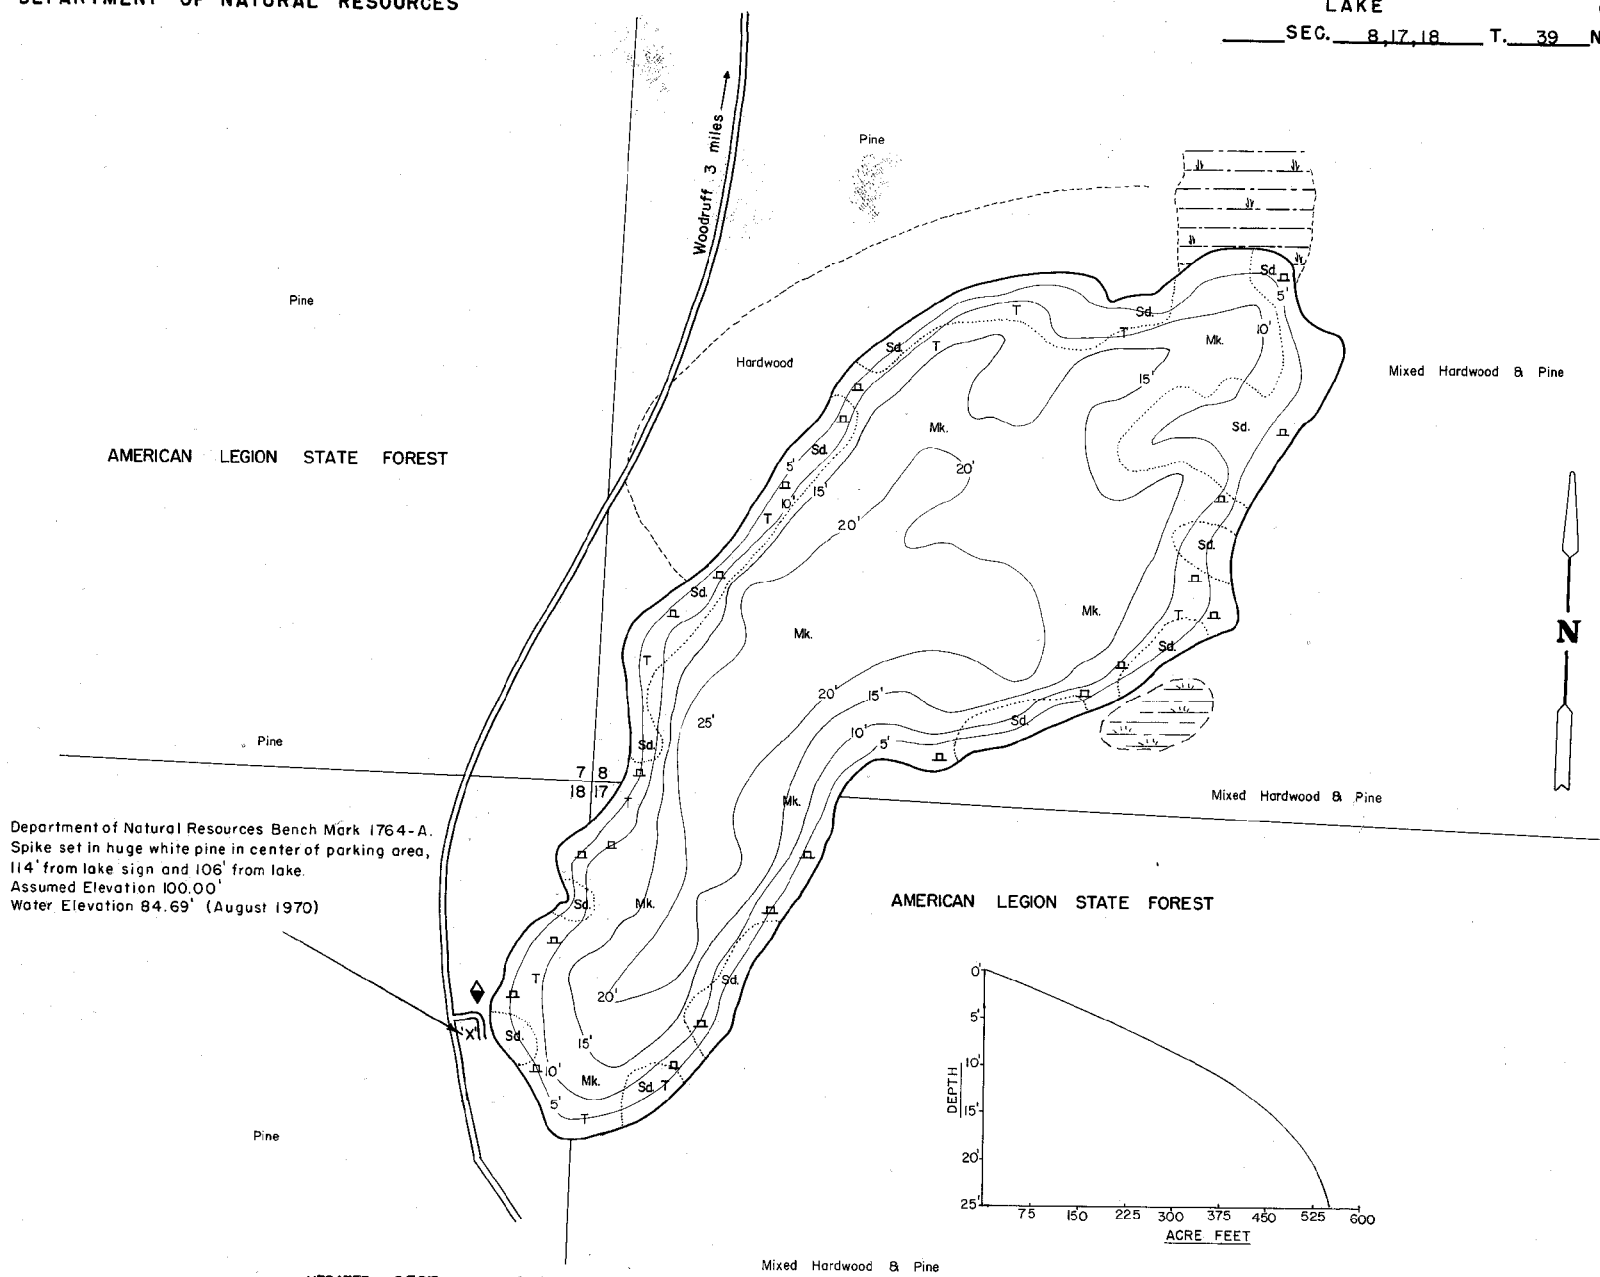
Department of Natural Resources Bench Mark 1764-A.  
Spike set in huge white pine in center of parking area,  
114' from lake sign and 106' from lake.  
Assumed Elevation 100.00'  
Water Elevation 84.69' (August 1970)

WATER AREA 40.4 ACRES  
UNDER 3 FT. 10 %  
OVER 20 FT. 20 %  
MAX. DEPTH 25 FEET.  
TOTAL ALK. 3 P.P.M.
