WISCONSIN CONSERVATION DEPARTMENT

LAKE SURVEY MAP

FRIEDA LAKE RACINE COUNTY
 S.W. 1/4 SEC. 20 T. 3 N. R. 19 E. 34

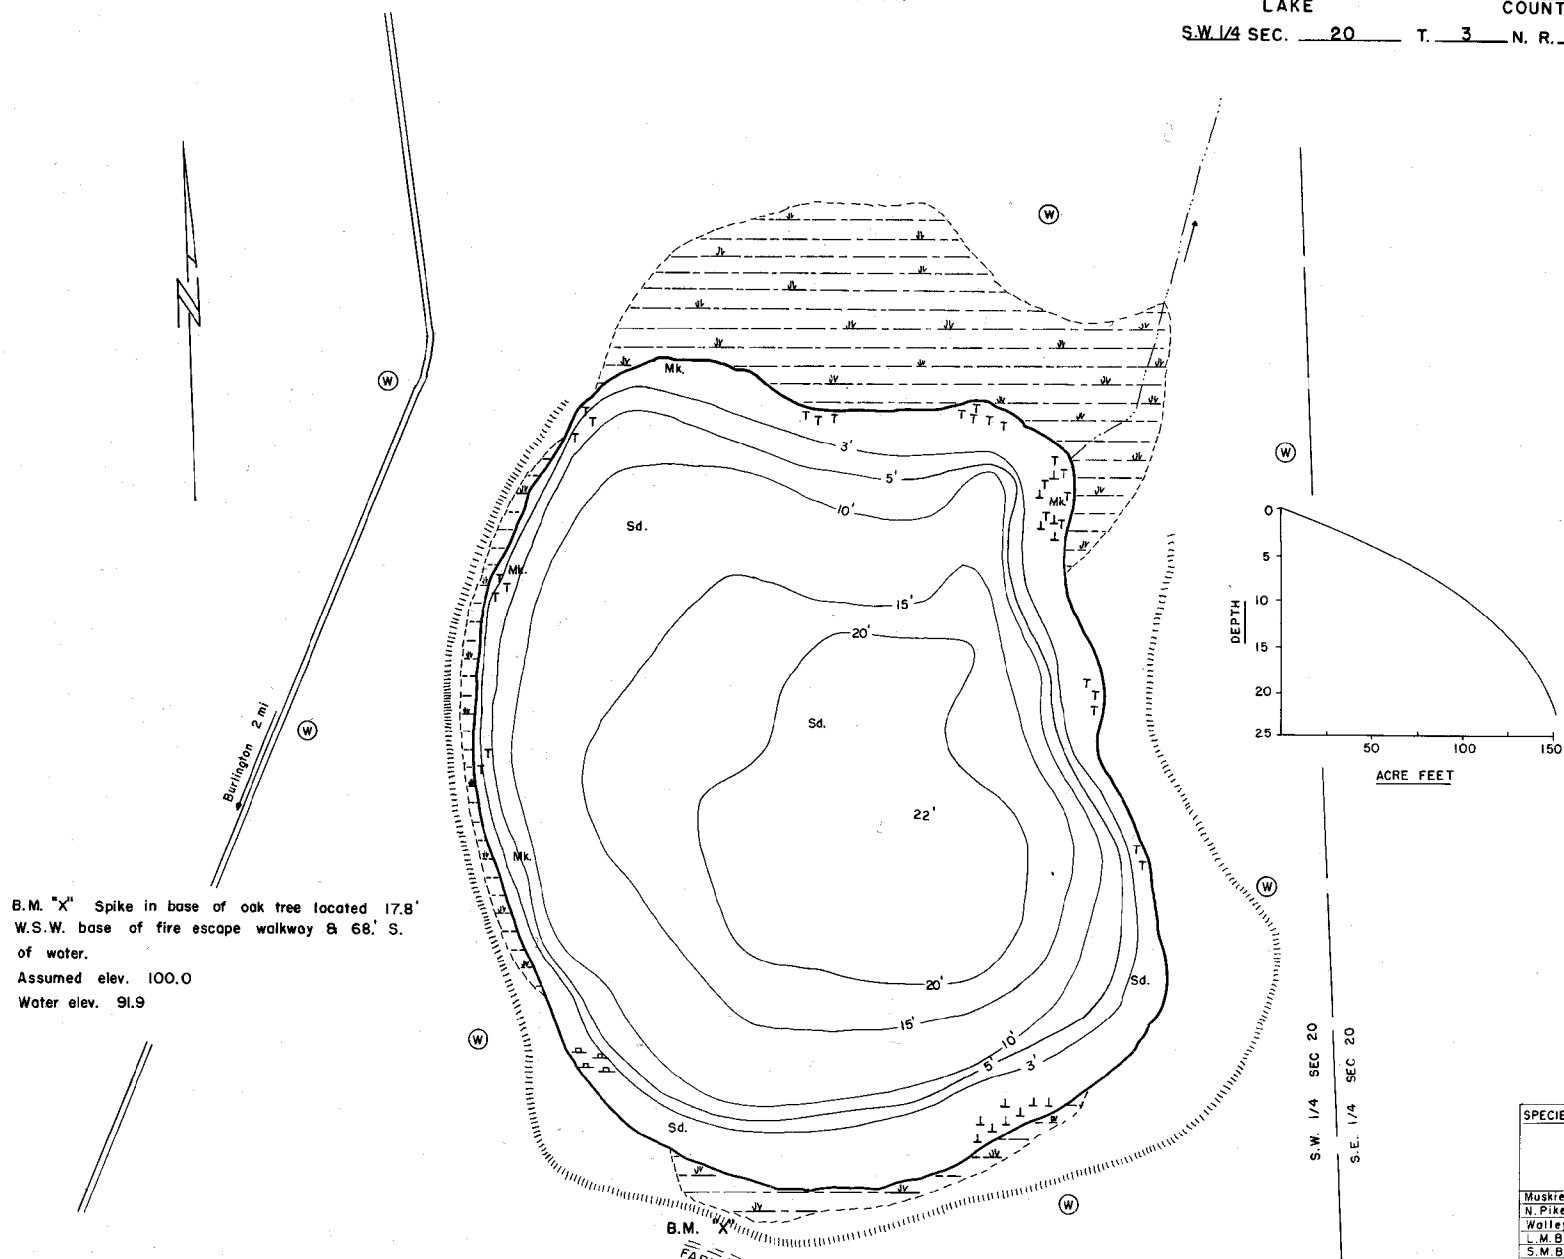
B.M. "X" Spike in base of oak tree located 17.8' W.S.W. base of fire escape walkway & 68' S. of water.
 Assumed elev. 100.0
 Water elev. 91.9

WATER ELEV. 91.9

AREA 12.5 ACRES
 UNDER 3FT. 16.8 %
 OVER 20FT. 19 %
 VOLUME 150.8 ACRE FT.
 TOTAL ALK. 221 P.P.M.
 SHORELINE 5 MILES

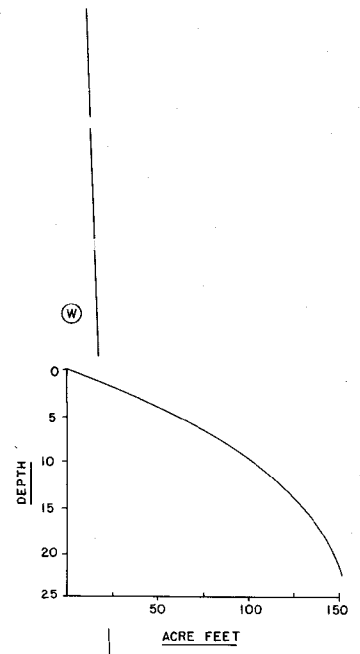
EQUIPMENT RECORDING SONAR MAPPED JUNE 1966
 MO. YR.
